# Manhole Inspection Summary

Manhole # S27G\_\_009MH

Insp Date: **5/21/08 9:28 AM**

**Location** Address: **8 Booth st**

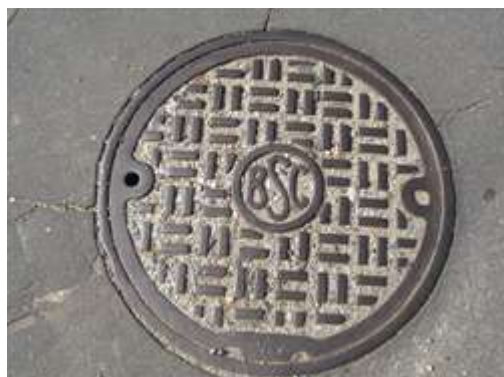
Cover View

Condition: **Sound**

Condition: ☐ Sound ☐ Cracked ☒ **Leaks**

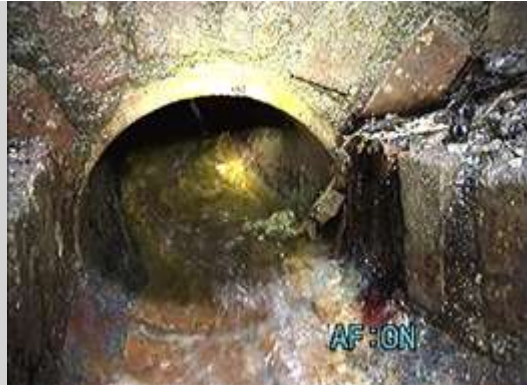
12 O'Clock Outflow

Pipe Height: **8.4** (in.) Rod and Bar (Angled)  
Pipe Material: **Clay** ☐ Pipe Lined  
Invert Depth: **8.38** (ft.) Flow Characteristics: **Fast**  
Deposits: ☒ None ☐ Mud ☐ Sludge ☐ Debris ☐ Grease  
Silt Depth: **0** (in.) Deposits Extent:  
Infiltration: **None** Pipe Seal Cond: **Sound**

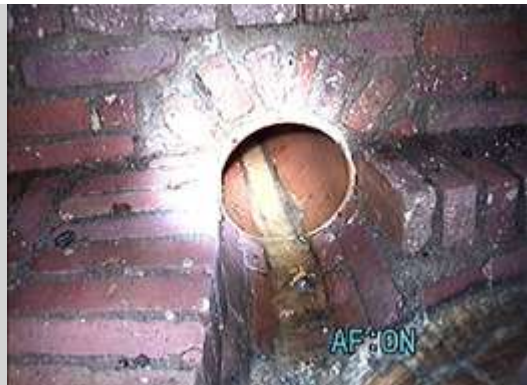
4 O'Clock Inflow

Pipe Height: **8.4** (in.) Rod and Bar (Angled)  
Pipe Material: **Clay** ☐ Pipe Lined  
Invert Depth: **8.90** (ft.) Flow Characteristics: **Slow**  
Deposits: ☒ None ☐ Mud ☐ Sludge ☐ Debris ☐ Grease  
Silt Depth: **0** (in.) Deposits Extent:  
Infiltration: **None** Pipe Seal Cond: **Sound**
